DUBNICA Armament Plant.

CROSS SECTION OF THE UNDERGROUND BUILDING.

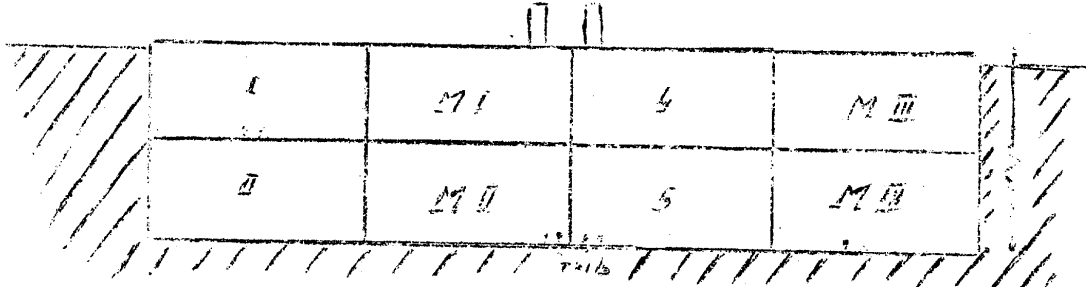
- I } Depots for machine parts, tools, etc. These rooms had been blown up at the end of the war and were still being reconstructed in the fall of 1949.
- II }
- 4 } Forge and pressing shop.
- 5 } Thermal center with two steam turbines, supplying the plant with power. In the fall of 1949 it was still not in operation. Repair work on machines and other installations was still going on at that time.
- MI } Before its destruction the boiler installation consumed two carloads*. Workshop for manufacturing fuses for shells. This shop, which had been blasted at end of war, was still being reconstructed in fall of 1949.
- MII } Workshops for manufacturing guns as well as elevating and traversing mechanisms. Some of these shops were in operation. Three sets of tracks lead into the underground building.

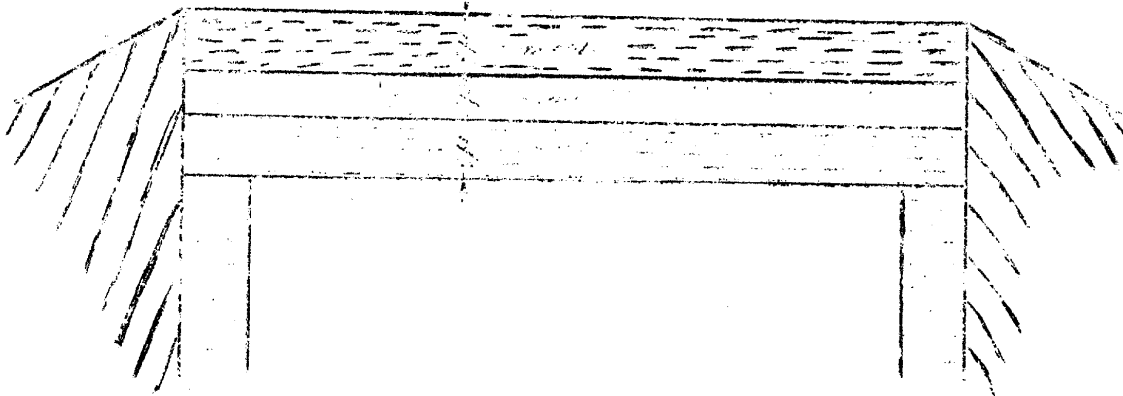
CROSS SECTION OF THE CEILING OF THE BUILDING

The ceiling is made of reinforced concrete. [redacted]

[redacted] this ceiling comprises a concrete cover 1.5 meters thick, a layer of sand, and a second concrete cover about 1.5 meters thick built subsequently as reinforcement. [redacted] estimate the ceiling to be 2.4 to 4 meters thick.
